Construction & Quarrying

Sand Elevator Replacement

To replace an existing, worn out, sand elevator.

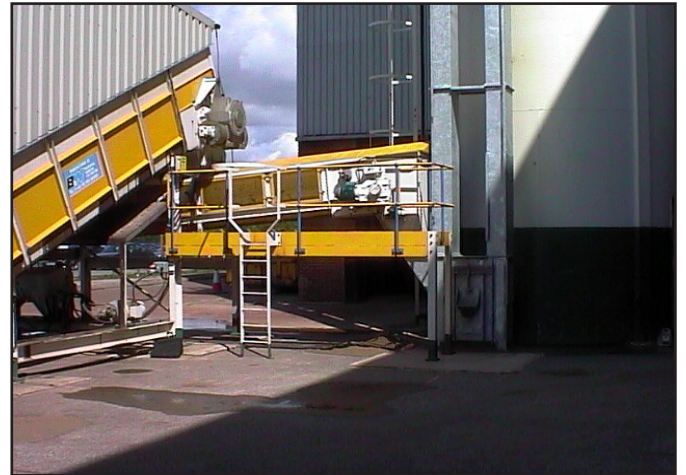
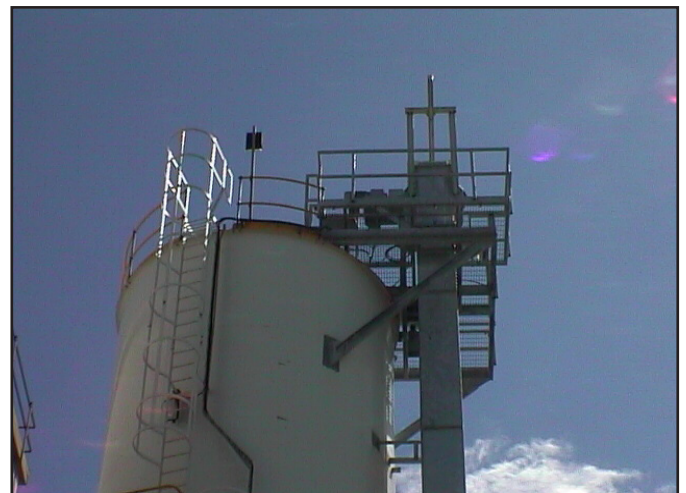
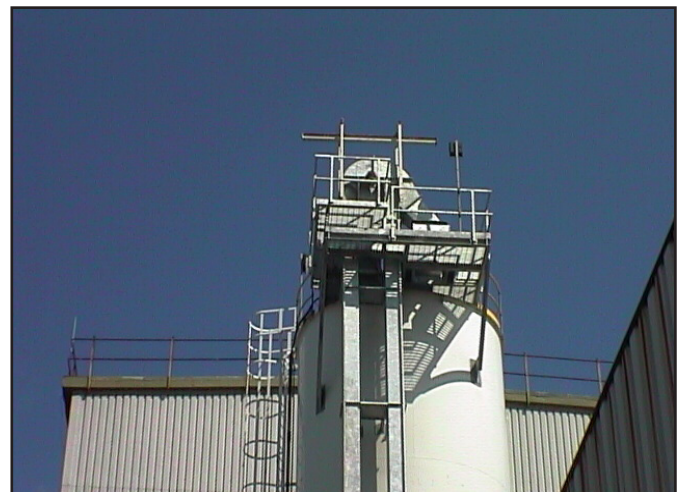
The client needed to replace an existing sand elevator which had worn out. The existing elevator had down legging due to product sticking in the buckets, the salt in the sand was corroding the buckets and the bucket shape was wrong for the application.

This was manufactured from mild steel with removable UHMW Polyethylene liners. The new heavy-duty belt and bucket elevator was designed to lift 50TPH of damp sand with a bulk density of 1.4 tonnes/m³ 25 metres. The elevator head, boot and leg casings are galvanised for protection against corrosion.

GAME also manufactured and installed a platform and support mounted to the silo top and extending out around the elevator, used to maintain the elevator and to support a new vibratory feed tray.

GAME initially removed the existing elevator and manufactured and installed a new inlet transition between the existing cross feed belt conveyor and the elevator inlet.
